Photographs: **CHAMBER OF COMMERCE BUILDING**

PHOENIX SKY HARBOR INTERNATIONAL AIRPORT Terminal 2

Building Location: 3400 East Sky Harbor Boulevard Phoenix, Arizona

Date of Site Visit: 11/13/06

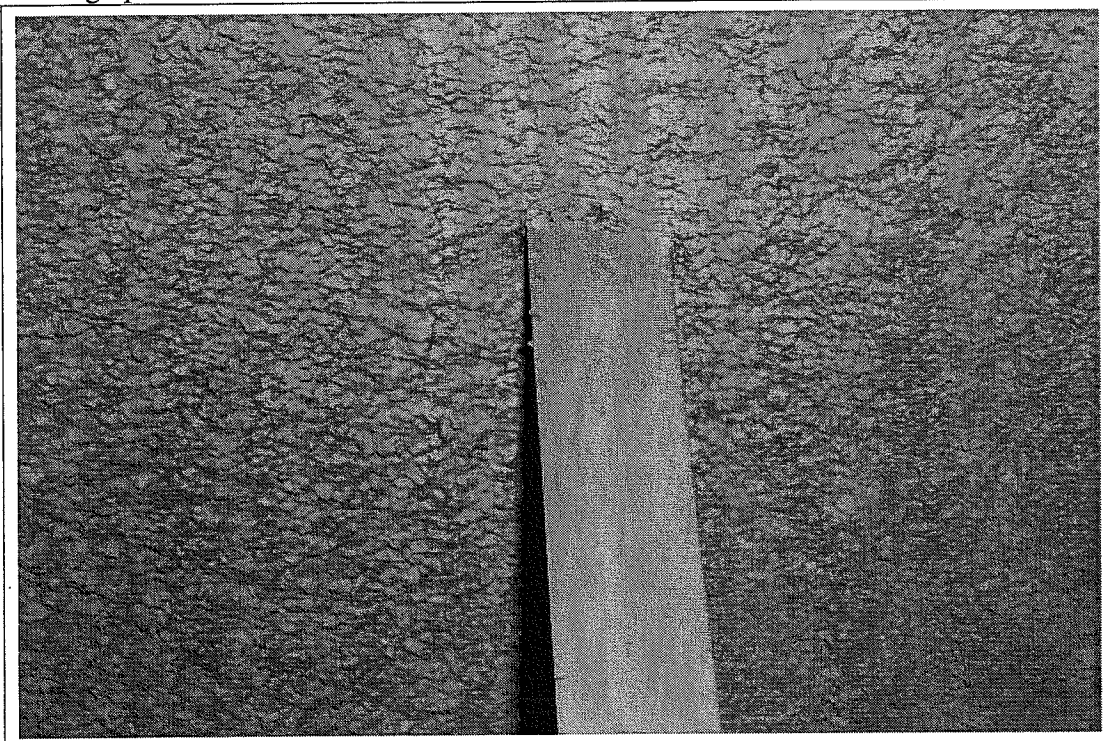
Photo 93. Basement, back hallway at janitors storage area - Duct support strap attached to acoustical plaster ceiling

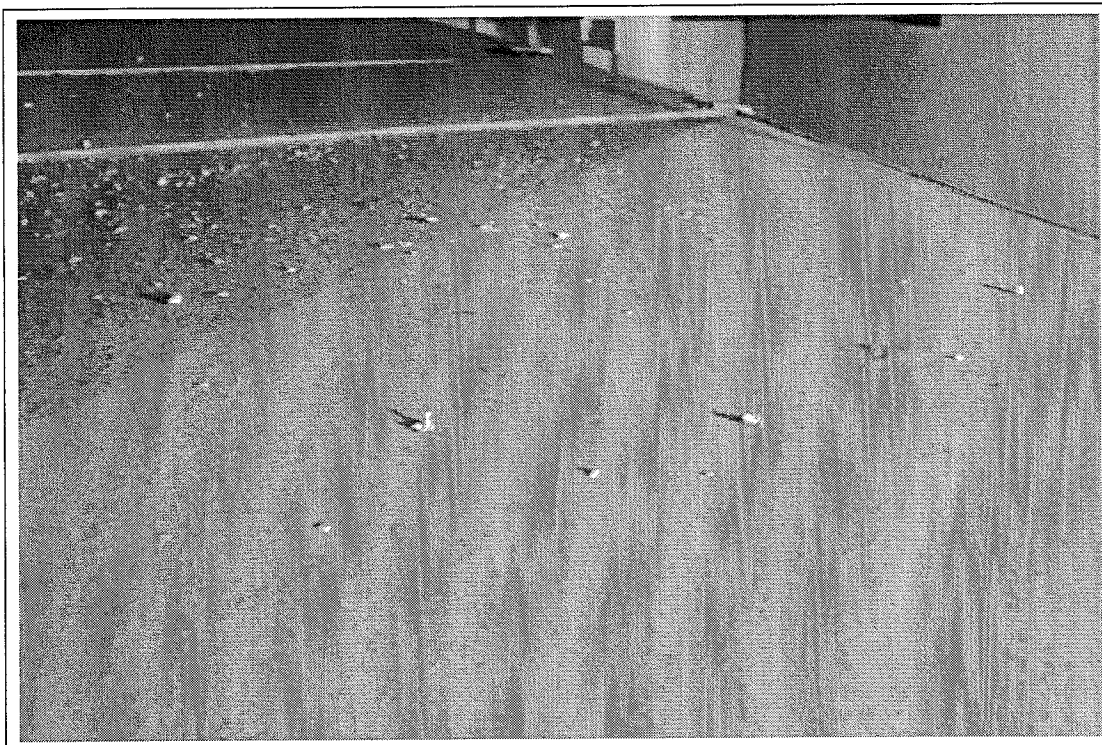
Direct Prep Analysis of the two surface contact samples revealed the presence of free un-encapsulated Chrysotile asbestos fibers in each of the samples. This data confirms the release of respirable fibers from the acoustical plaster present in the subject building.

Photo 94. Basement, back hallway at janitor's storage area - Close-up of delaminated acoustical plaster dust and debris on top of duct work

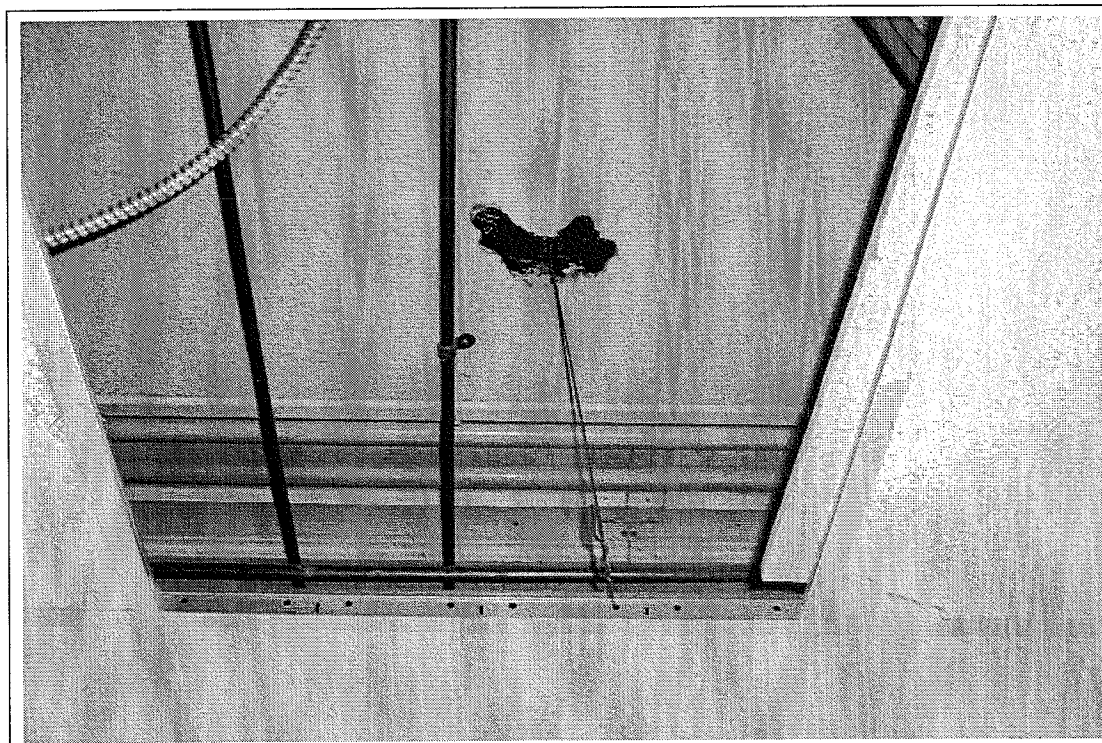
Photo 95. 1st floor, City Counsel Chambers - View of acoustical plaster ceiling located above suspended ceiling

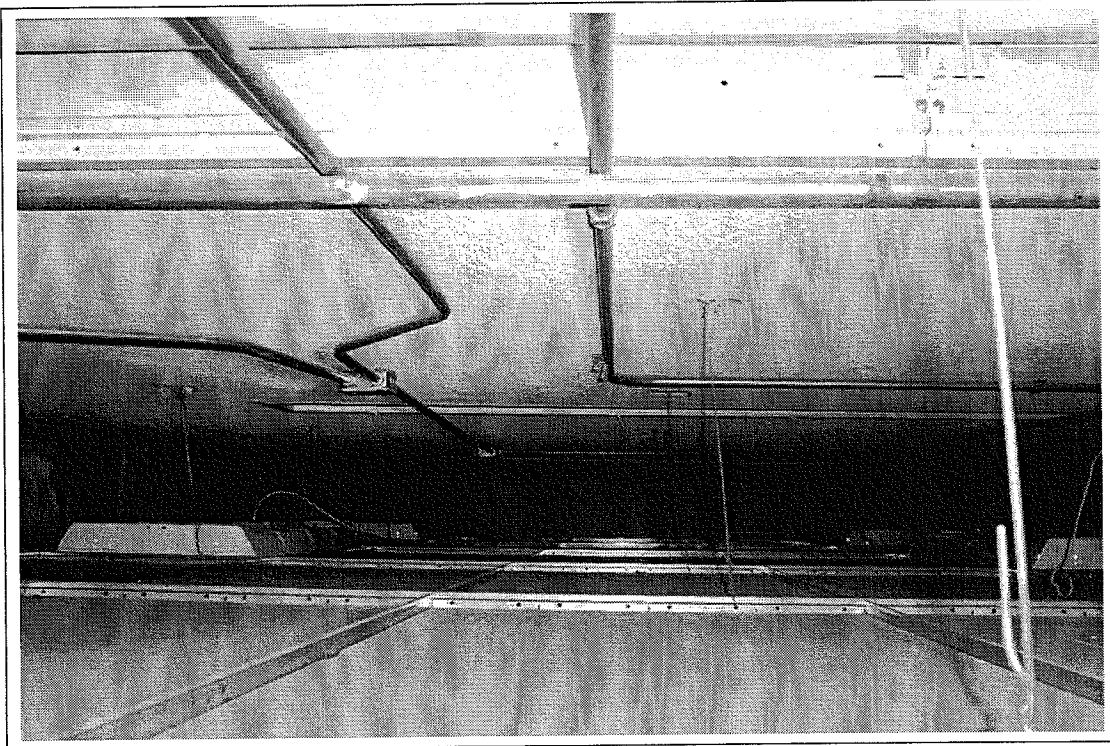
Photo 96. 1st floor, City Counsel Chambers - General view of hanger wires and electrical conduit attached to acoustical sprayed ceiling

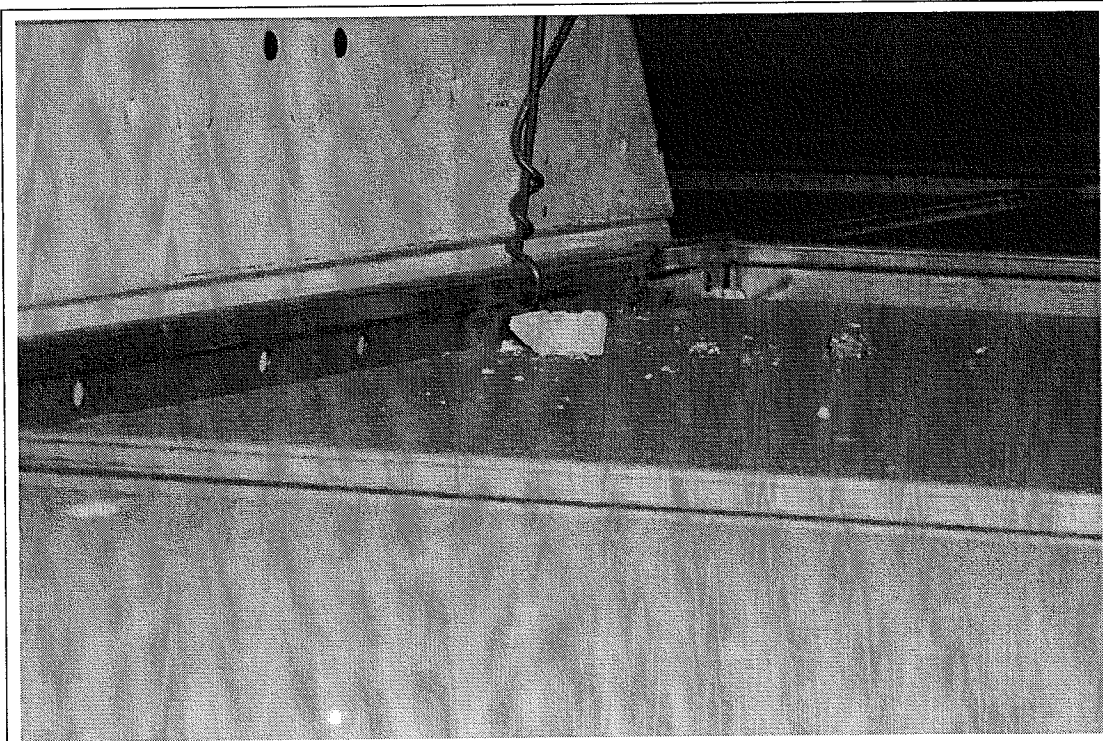
Photo 97. 1st floor, City Counsel Chambers - Close-up of dislodged acoustical plaster debris on top of ceiling tile (location of dust sample #3)

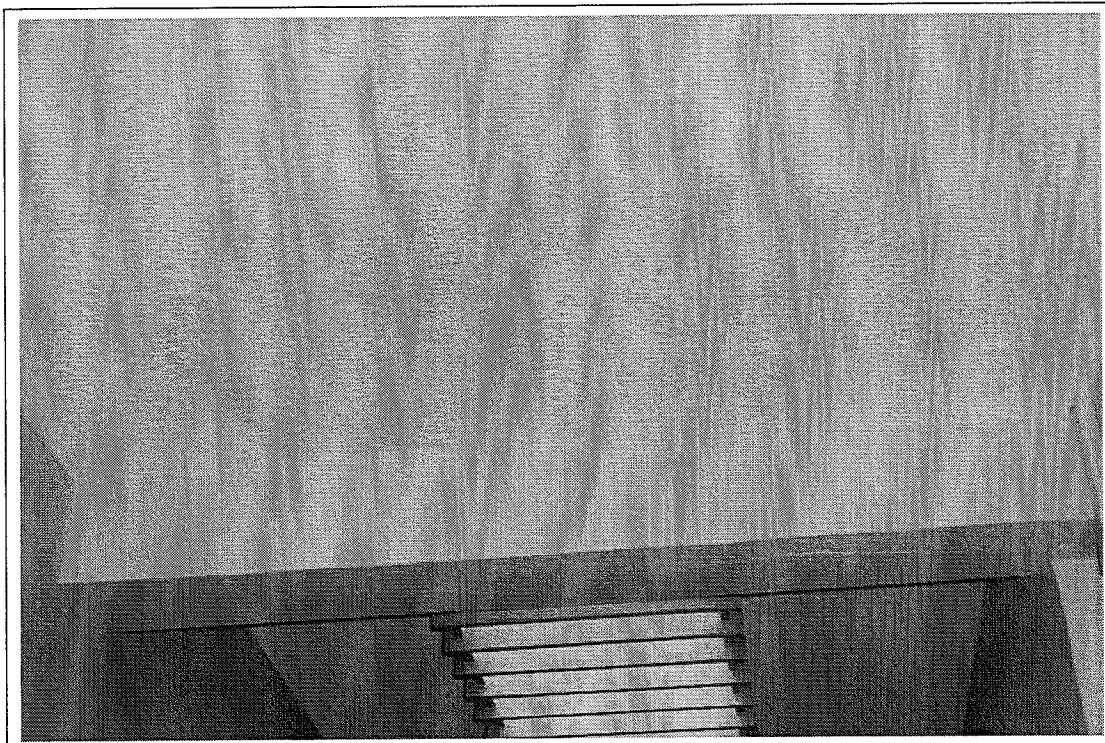
Photo 98. 2nd floor, hallway outside offices - View of water damaged acoustical plaster

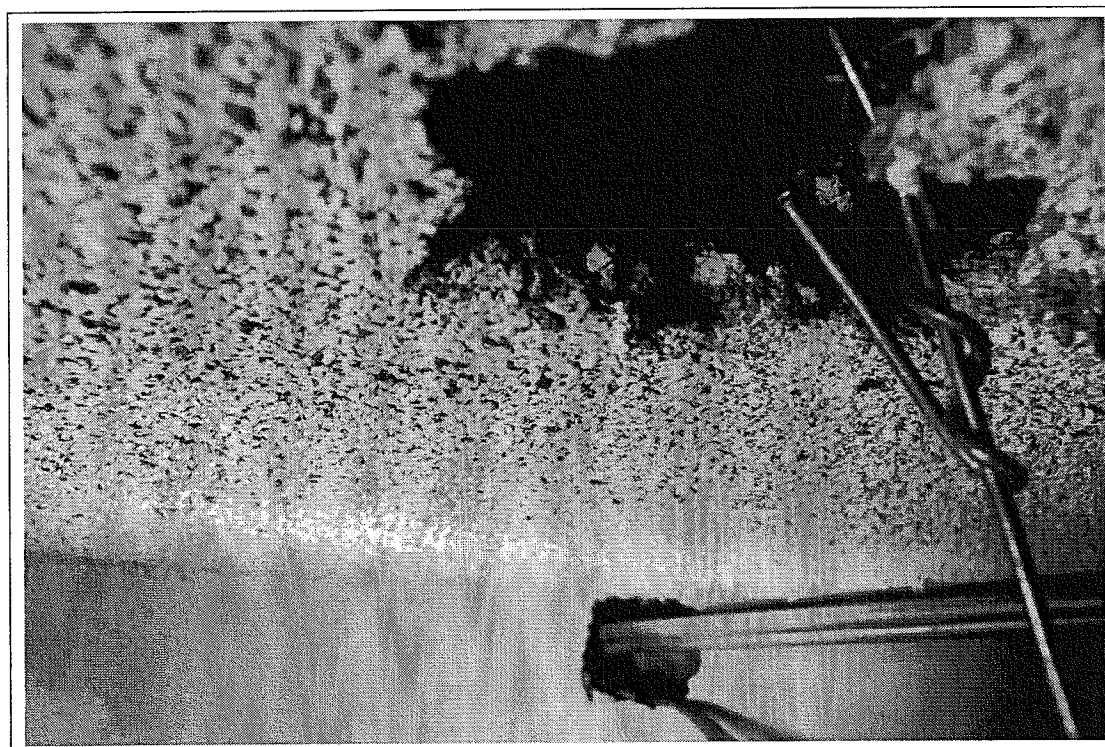
Photo 99. 2nd floor, hallway and copy area - Close-up of damaged acoustical plaster
(note: fibrous nature of material)
